B *Risk Control* BULLETIN

February 2012

HYDRO-PNEUMATIC TANK BEST PRACTICES

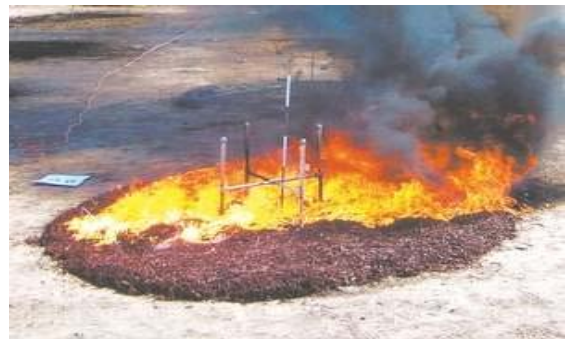
Background: CHUBB Group (JPIA's excess Property Coverage provider) was visiting several locations for a member of the ACWA/JPIA. CHUBB provides excess Property and Boiler and Machinery coverage for the ACWA/JPIA membership. When visiting a booster pumping station, where a new generator and propane tank had been installed, the CHUBB representative noted that they were walking on a bed several inches thick of ground up tires. The ACWA/JPIA member referred to this as "tire bark" (on the web as "rubber bark"). The member stated that they had done research into the product before selecting it for use as a ground cover. The primary purpose was for weed control. At the station visited, the material covered the entire fenced area of the station (about 1,000 square-feet) including around and under the propane tank, and all other station facilities. The area was not irrigated or otherwise landscaped.

In discussing the material with the member, CHUBB was informed that the member had experienced several instances where the material had ignited during hot work operations (cutting and grinding), and one involving an electrical problem. All fires were readily controlled without injury or property damage. CHUBB expressed concern and agreed to look into the material.

Studies show that wood and rubber mulch will burn easily, but if a fire starts, a wood mulch fire is easier to put out. When rubber bark mulch catches on fire, it will burn longer and hotter than wood mulch, and will be harder to extinguish. A rubber mulch fire will throw off black smoke, where the wood mulch will give off a whitish gray smoke that is not as toxic as the rubber fire. The potential for a fire is greater when mulch is used as a ground cover over a large non-irrigated area.

LC-2011-10-1 Ground Covering Materials: The wood and/or rubber bark (recycled tire) materials used for ground covering is combustible, and can spread an exterior fire throughout the exterior area. Rubber bark is comprised of rubber tires and burns similarly. There have been several fires where these materials increased fire damage to surrounding structures and equipment, where little fire spread would have occurred if non-combustible materials were used. CHUBB recommends replacement of the wood and/or rubber bark materials to a non-combustible stone aggregate material.

ACWA/JPIA members are encouraged to follow CHUBB's recommendation. These materials should be removed and replaced with non-flammable products when used:

- ❖ In large non-irrigated areas
- ❖ Close to buildings, facilities, and equipment
- ❖ Where hot work operations could occur, or exposed to sources of ignition
