SAFETY ALERT

ACWA/Joint Powers Insurance Authority, 5620 Birdcage Street, Suite 200, Citrus Heights, CA 95610-7632, (800) 231-5742

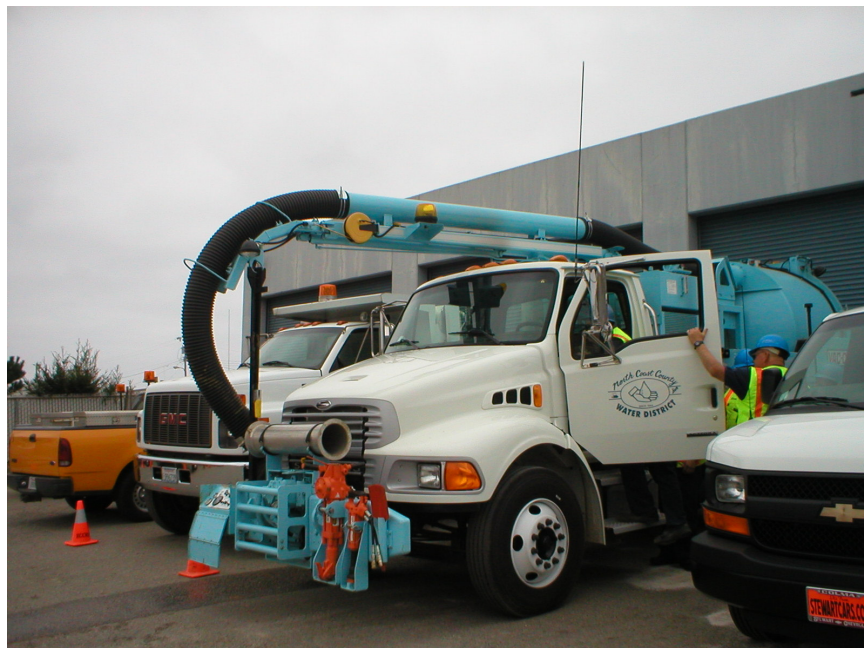
Recently, a 2003 Sterling Vac-Con Truck (see attached photo) operated by one of ACWA/JPIA's members caught fire during a vacuum operation. The fire was apparently caused when a hydraulic hose used to run the fan assembly came loose and dumped flammable hydraulic fluid onto the vehicle's hot exhaust system. The fire originated behind the cab and spread into the cab assembly. The truck, valued at \$145,000, was a total loss.

- a. Conduct a one-time focused inspection the hydraulic hoses and fittings of all similar vehicles. Particular attention should be placed to the hoses and connections in areas where failure could introduce hydraulic fluid to conditions that could cause combustion (heat, spark, flame).
- b. If not already called for in the operation or maintenance instructions associated with your equipment, periodically check the integrity of hydraulic hose connections.
