# H. R. LABOUNTY SAFETY AWARD PROGRAM NOMINATION FORM

Agency: Big Bear Municipal Water District

Reason for Nomination: Corrected unsafe conditions on own initiative

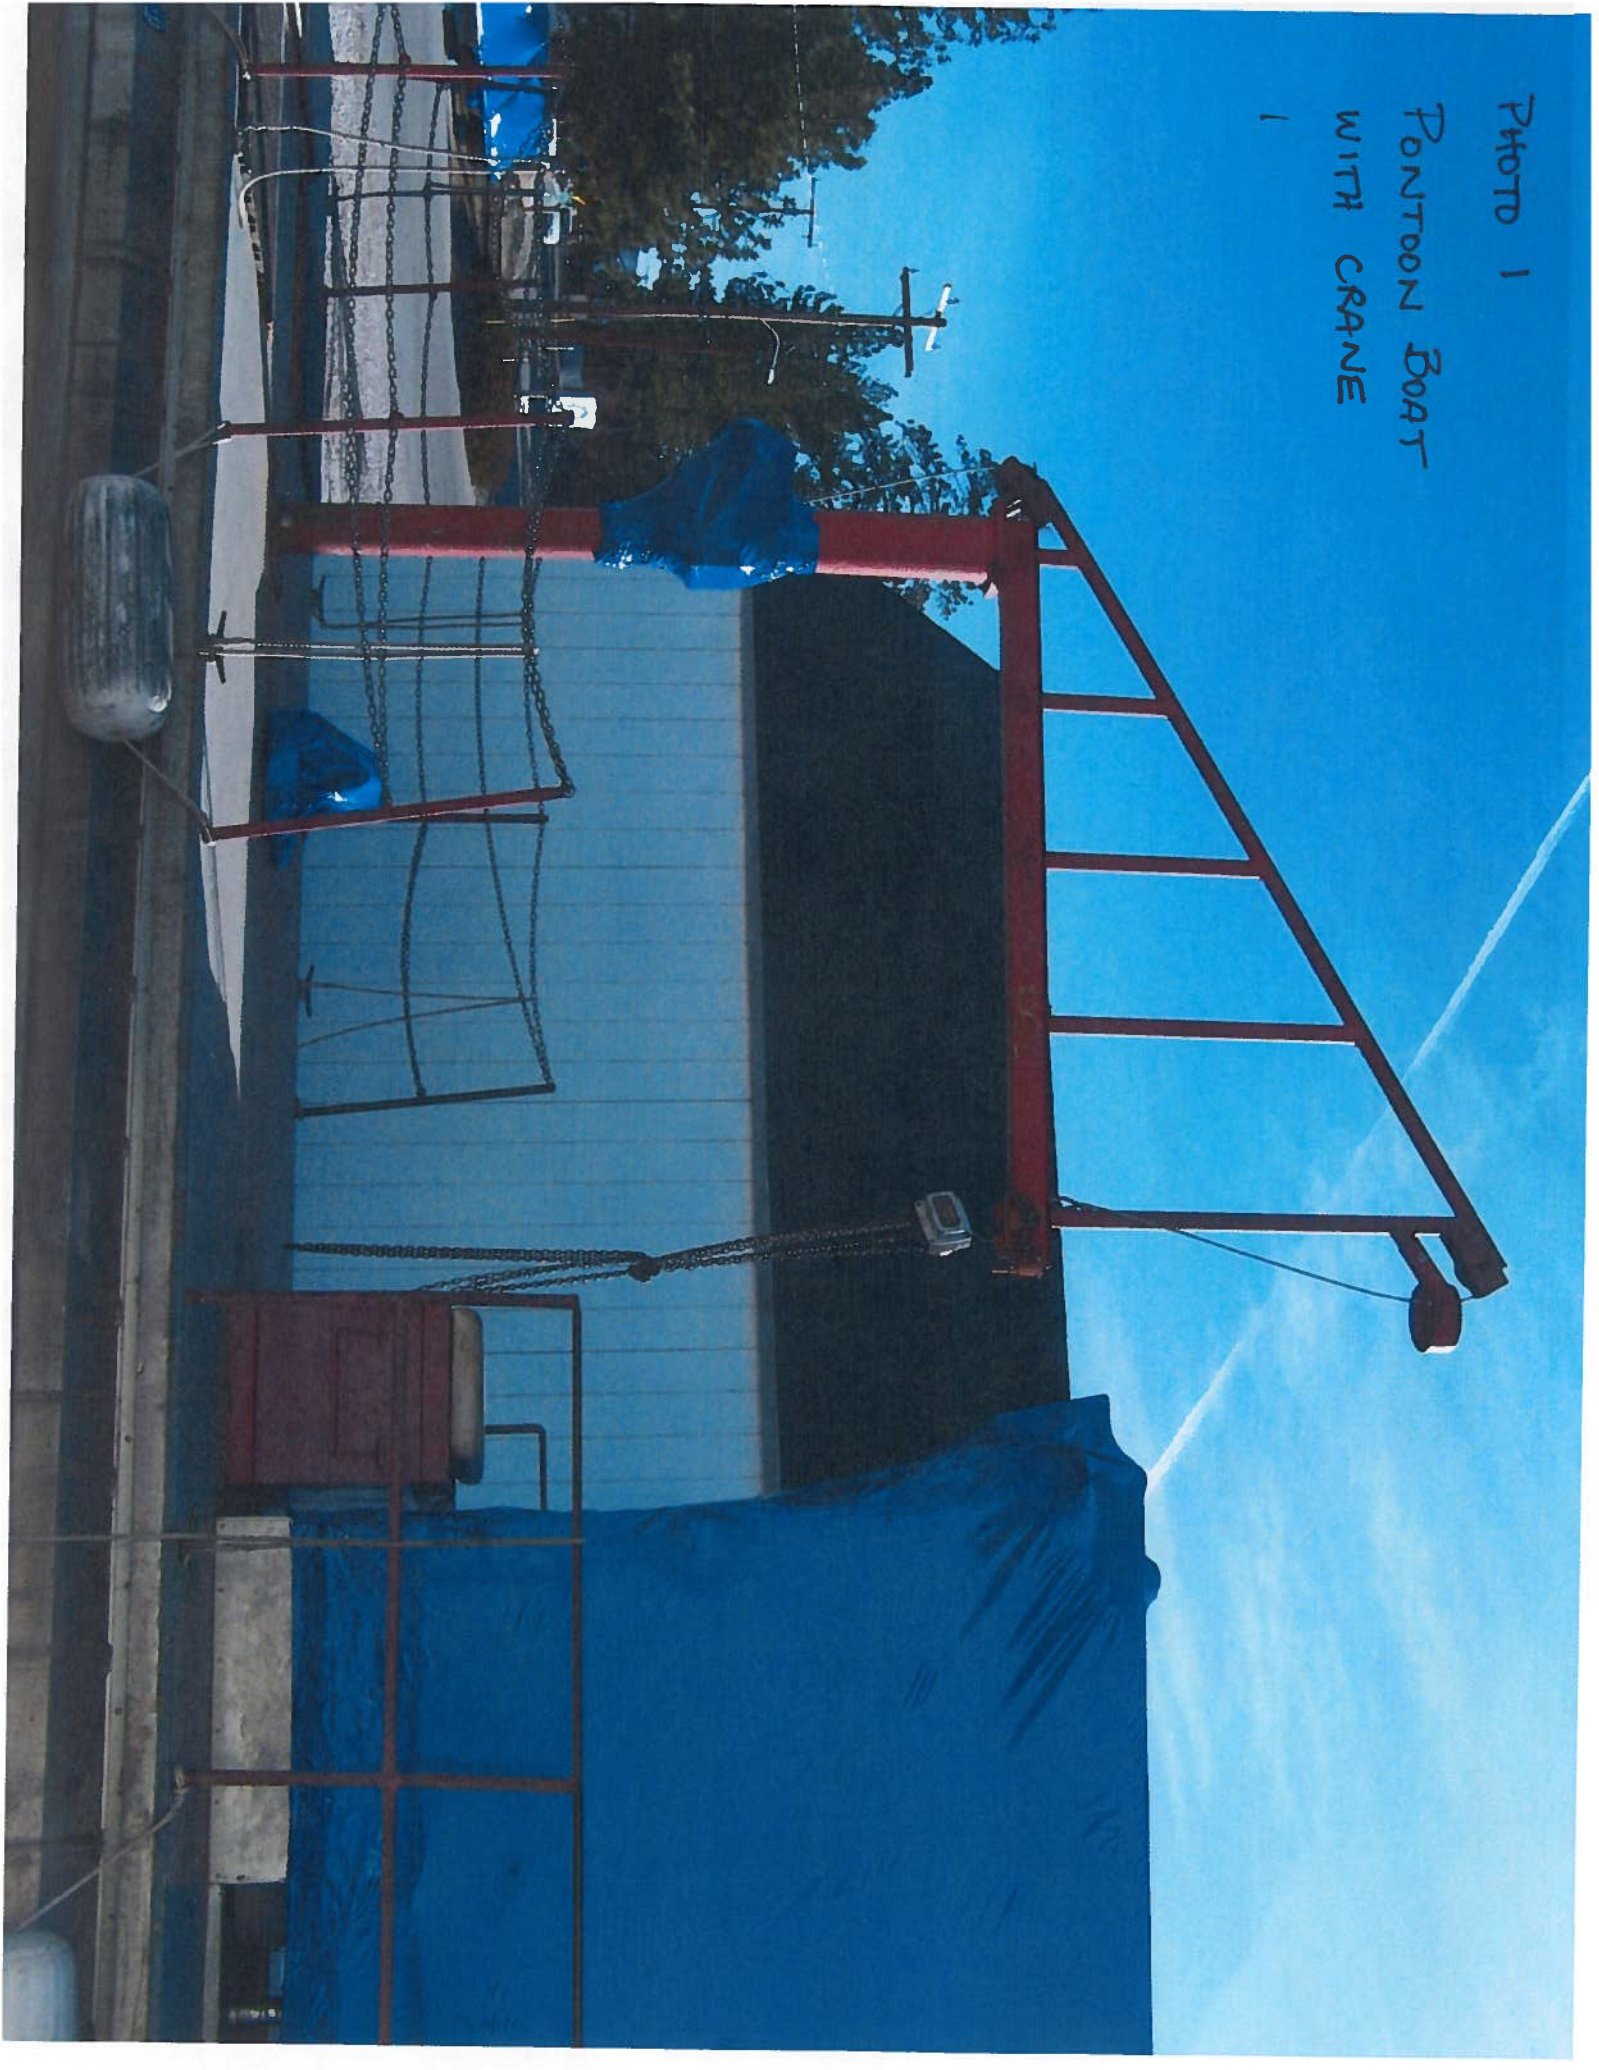
PHOTO 1  
PONTON BOAT  
WITH CRANE  
1

The Big Bear Municipal Water District uses a 30' pontoon boat with a crane on the lake for different maintenance duties. (Photo 1).

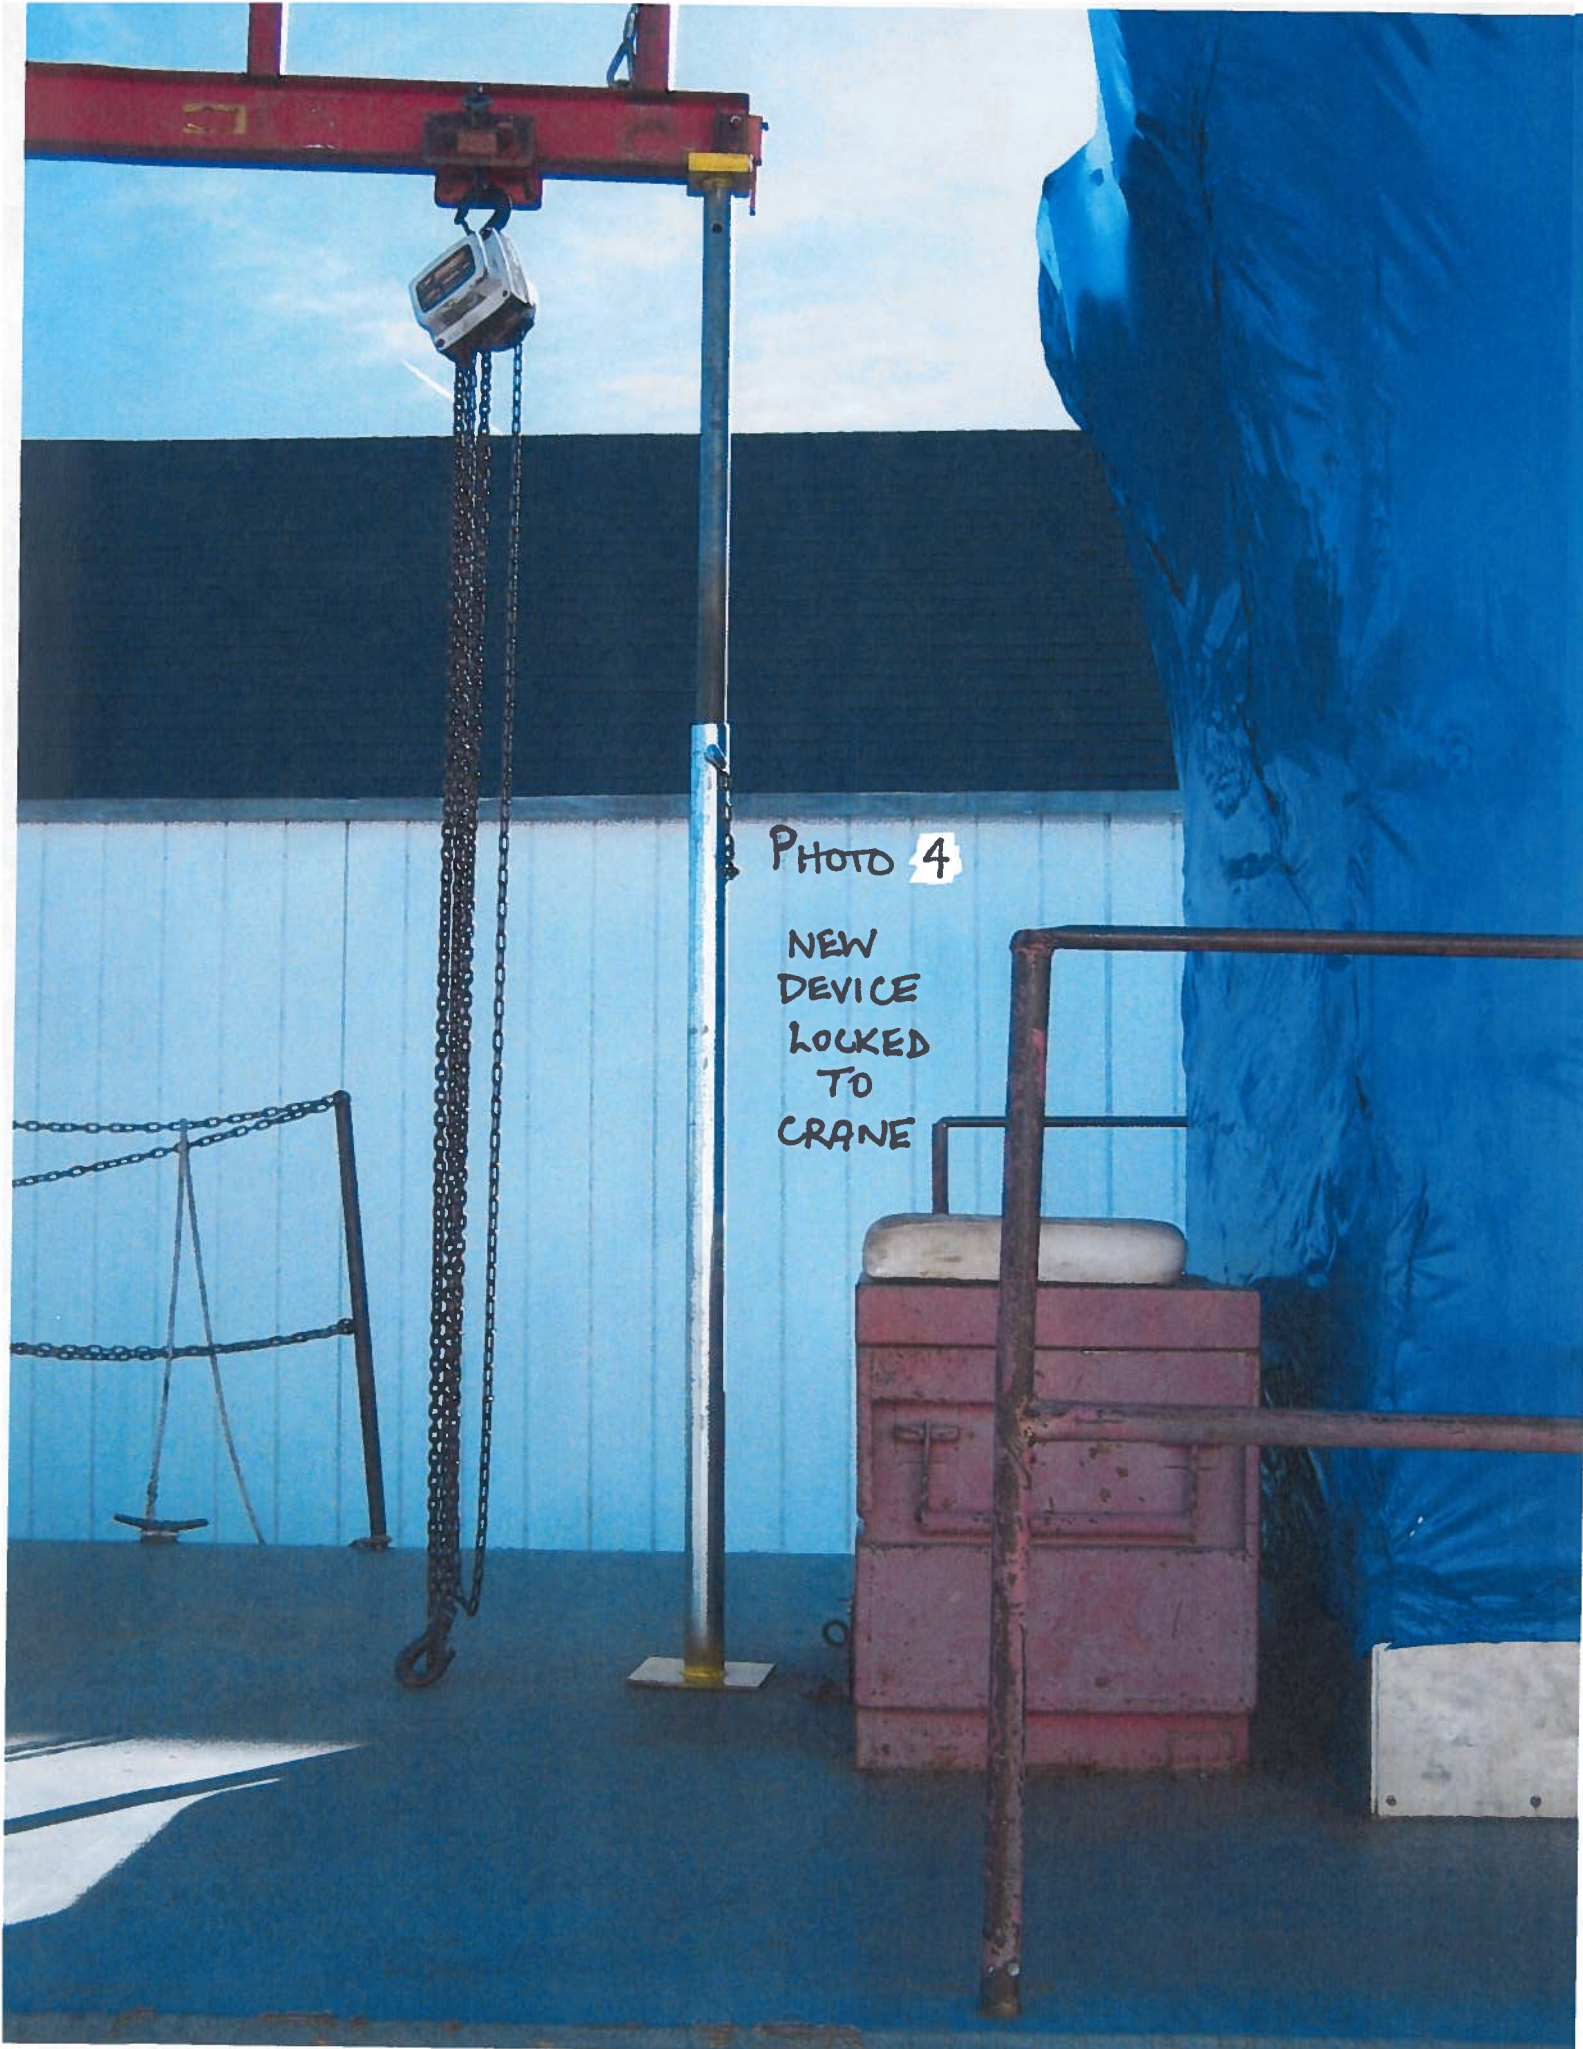
PHOTO 2

The first attempt to solve this problem resulting in creating a heavy steel brace constructed of a pipe with a saddle and foot (Photo 2) to keep the boat from tipping and also stabilize the crane and boat while pressure was applied to pull the dock pole. The saddle of the brace was placed under the crane with the foot being placed on the dock. Although this provided additional stability, once a dock pole pulled free the heavy steel brace would fall or shoot to the side putting the workers in danger.

OLD BRACING DEVICE  
NON-ADJUSTABLE  
DOES NOT SECURELY  
ATTACH TO CRANE.

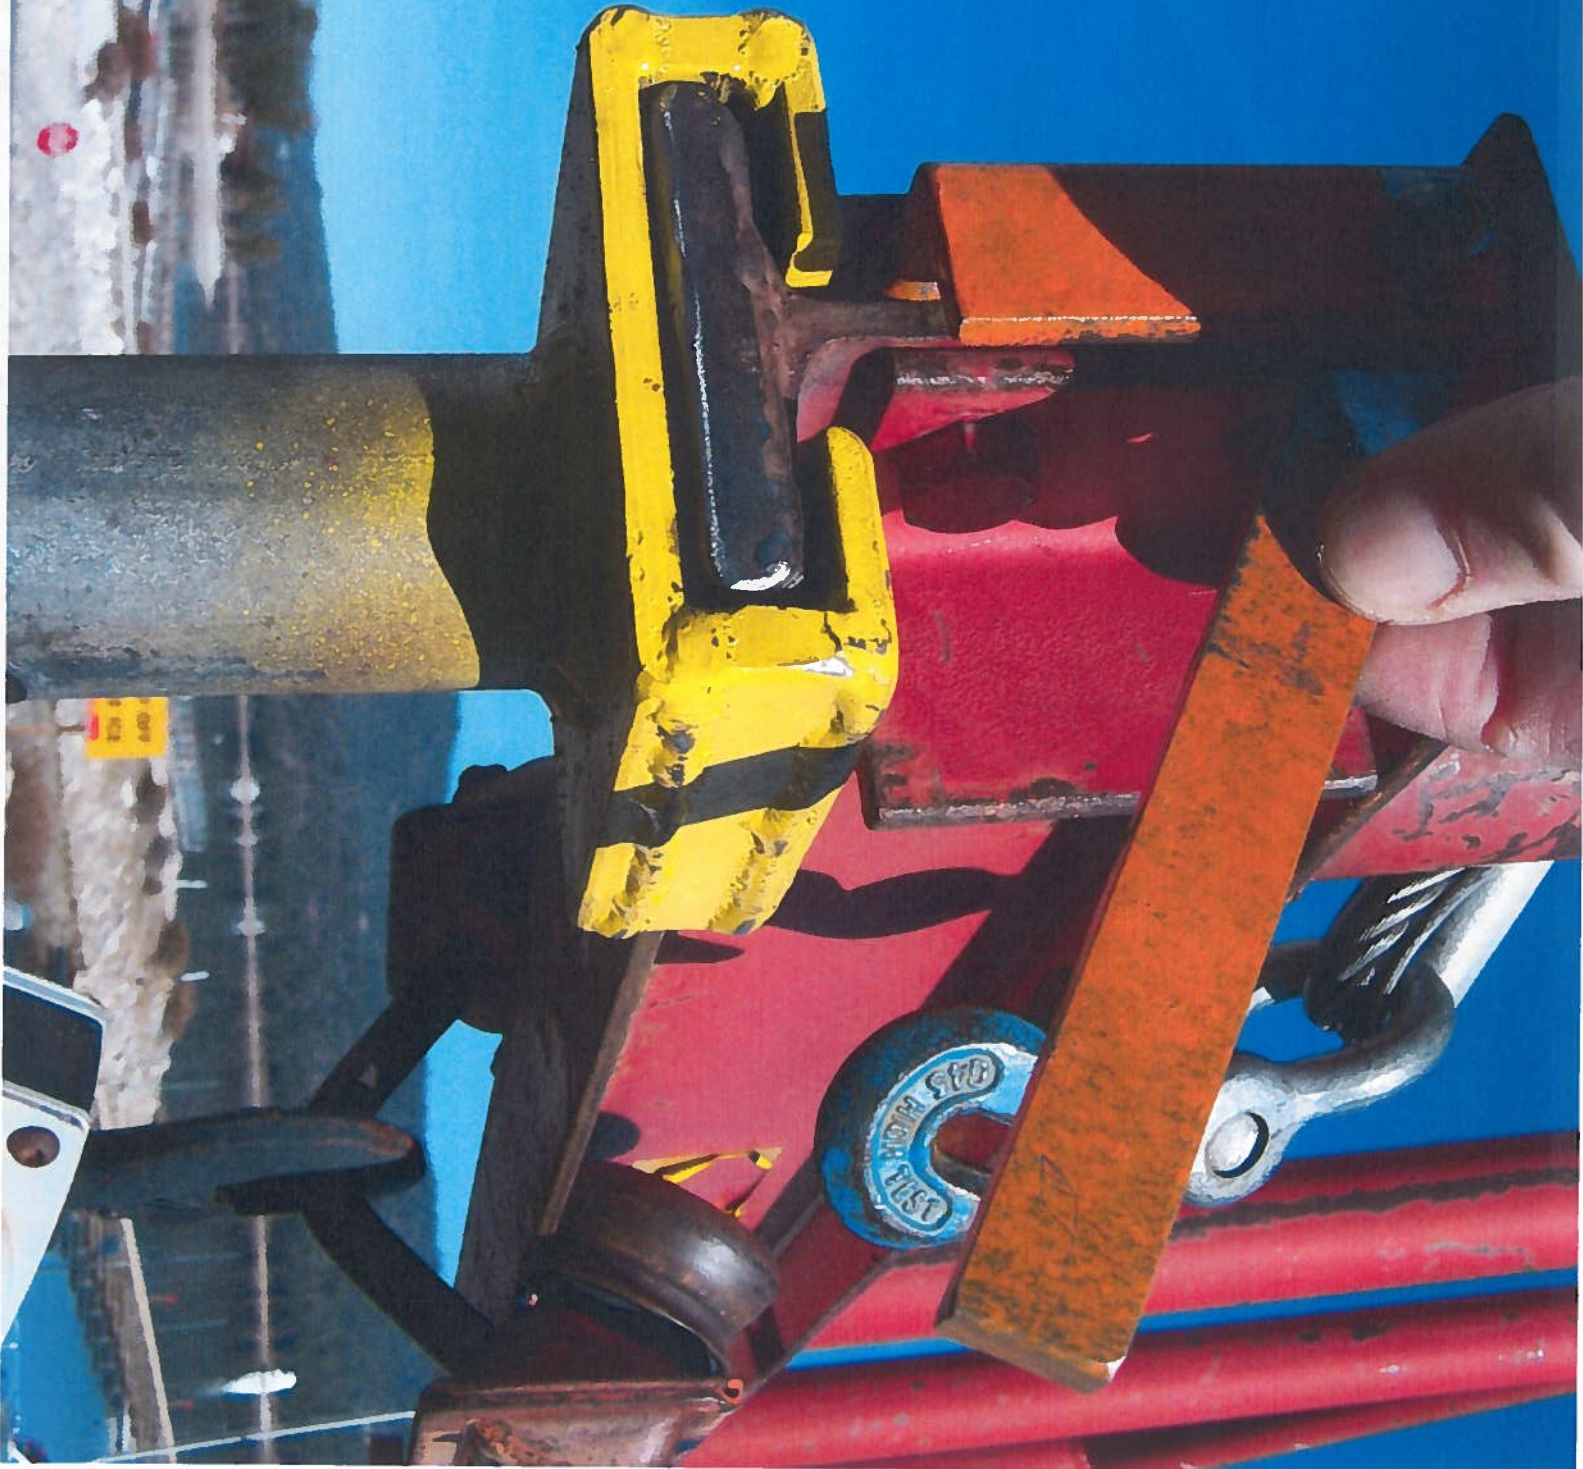
PHOTO 5  
LOCKING DEVICE  
OPEN

This winter, Facilities Technician John Tuttle took it upon himself to create a safer working environment by building a new style custom bracing device that is not only adjustable for different dock heights, but also can be easily attached to the end of the crane. (Photos 3 and 4). The bracket where the brace attaches to the crane is secured by a custom locking lever. (Photos 5, 6 and 7). Now, when a dock pole suddenly

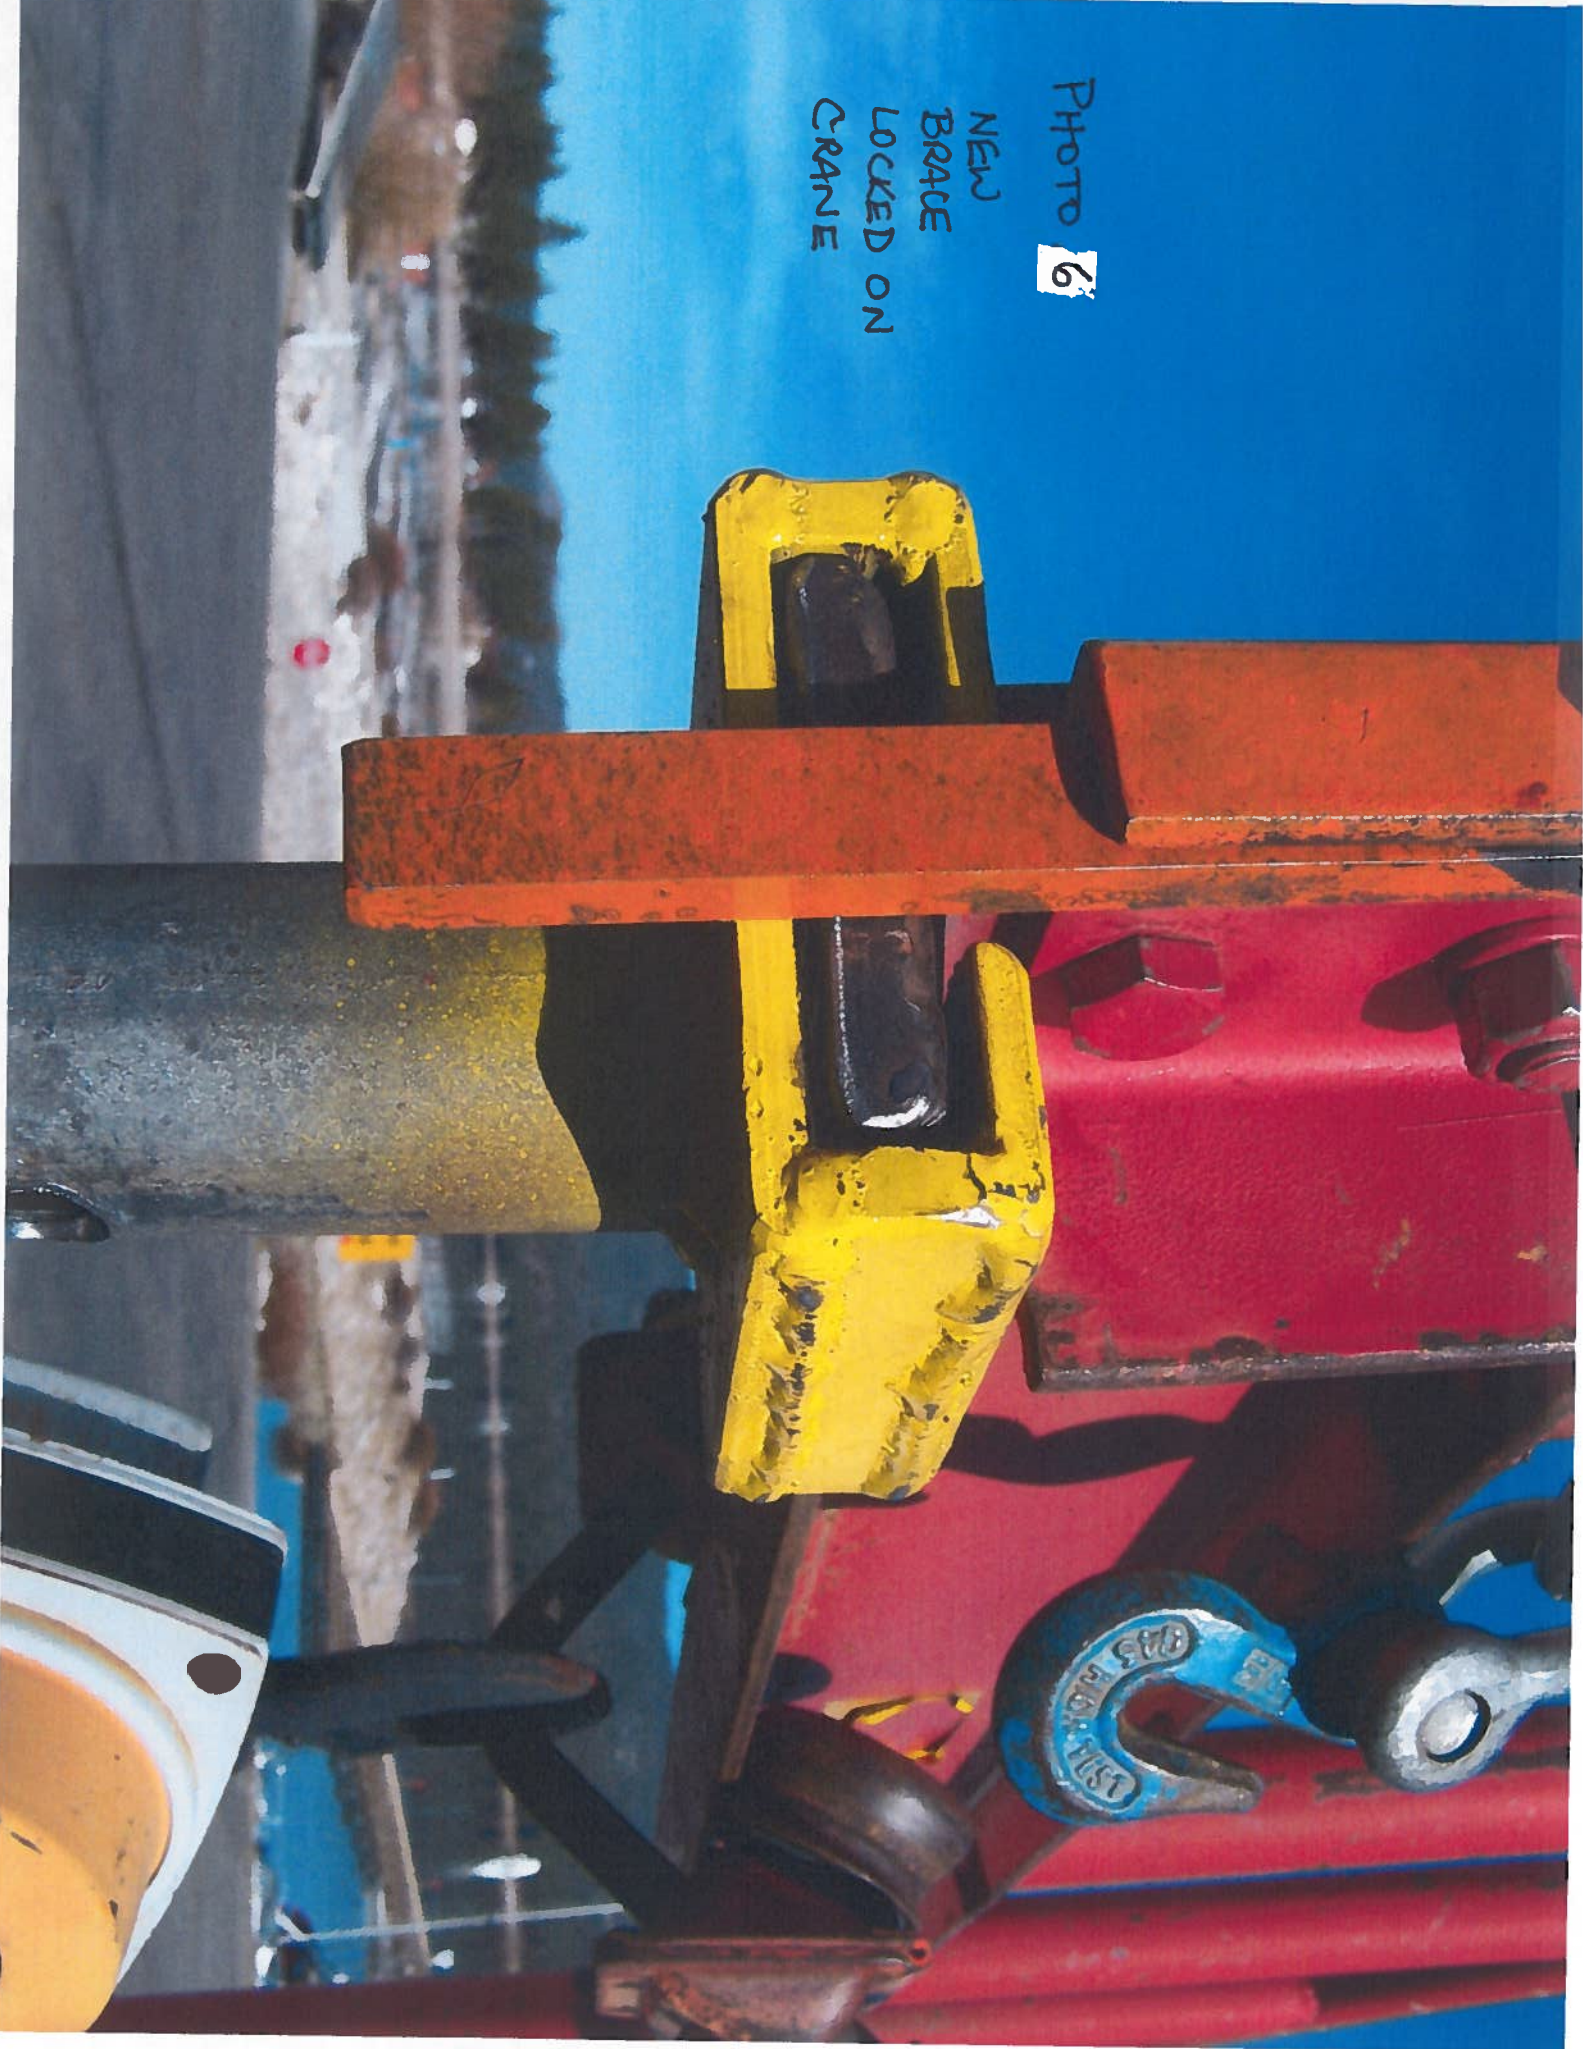
PHOTO 6

comes loose with all tension on the crane and brace suddenly relaxed, the bracing device stays with the crane and keeps the workers from the danger of being hit by an unsecured brace.

NEW  
BRACE  
LOCKED ON  
CRANE

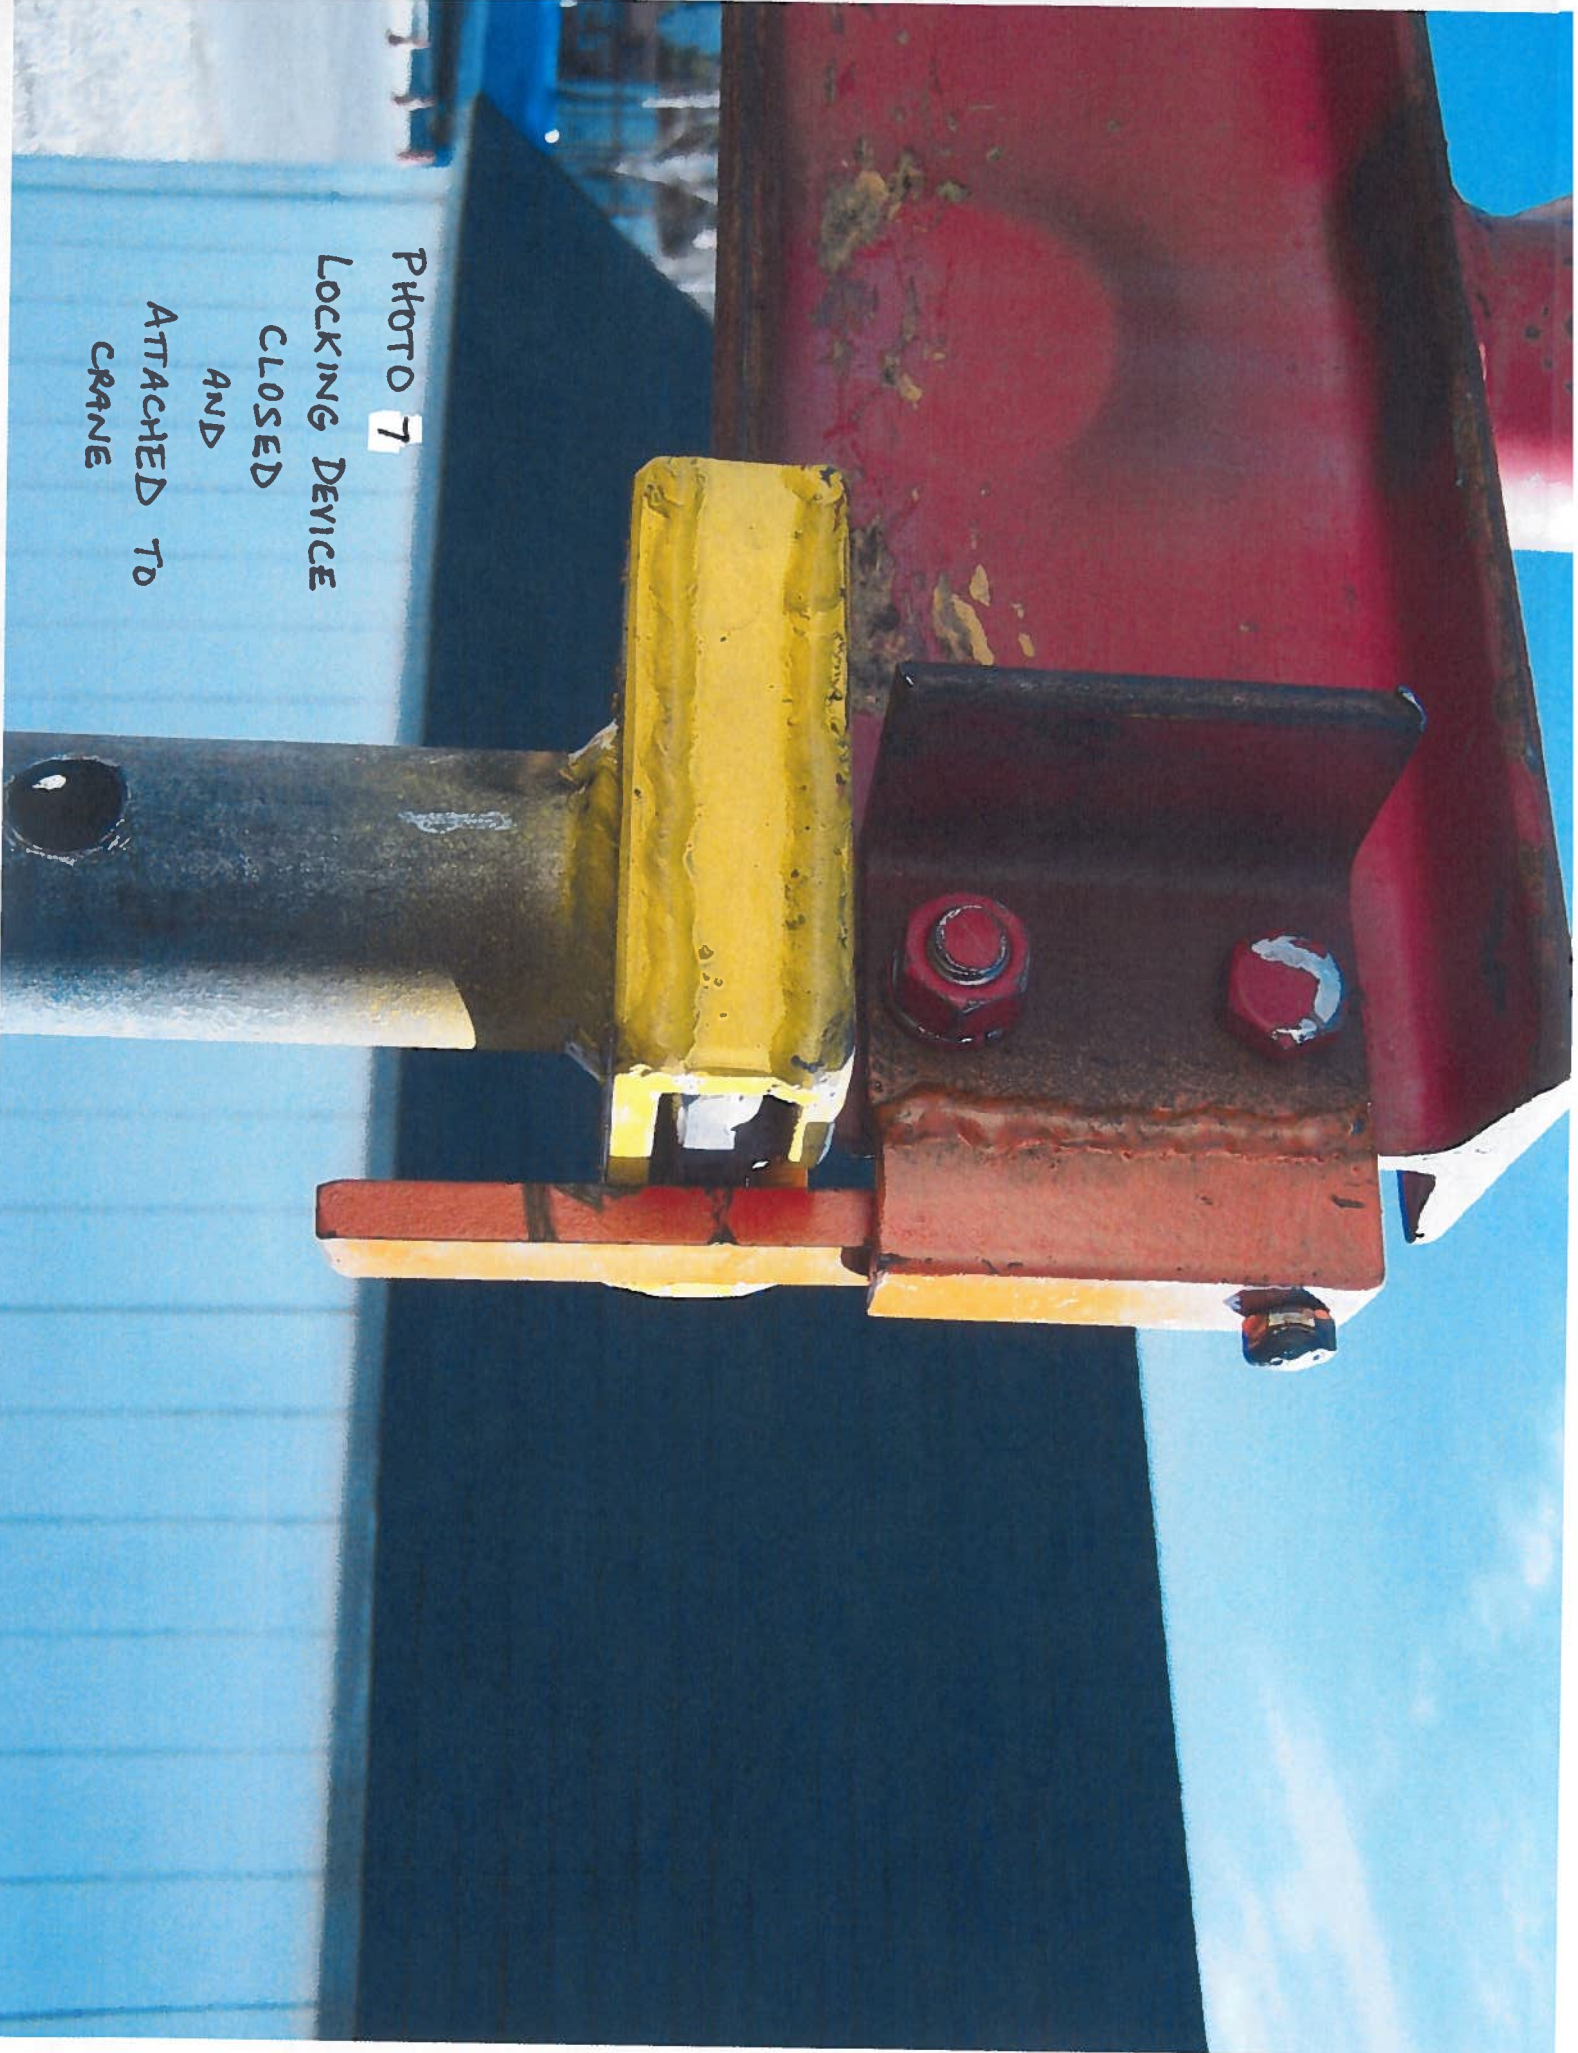
PHOTO 7

LOCKING DEVICE  
CLOSED  
AND  
ATTACHED TO  
CRANE
