H.R. LaBounty Safety Awards Nomination Form

Agency: Central Coast Water Authority

Name(s): Mark Swift

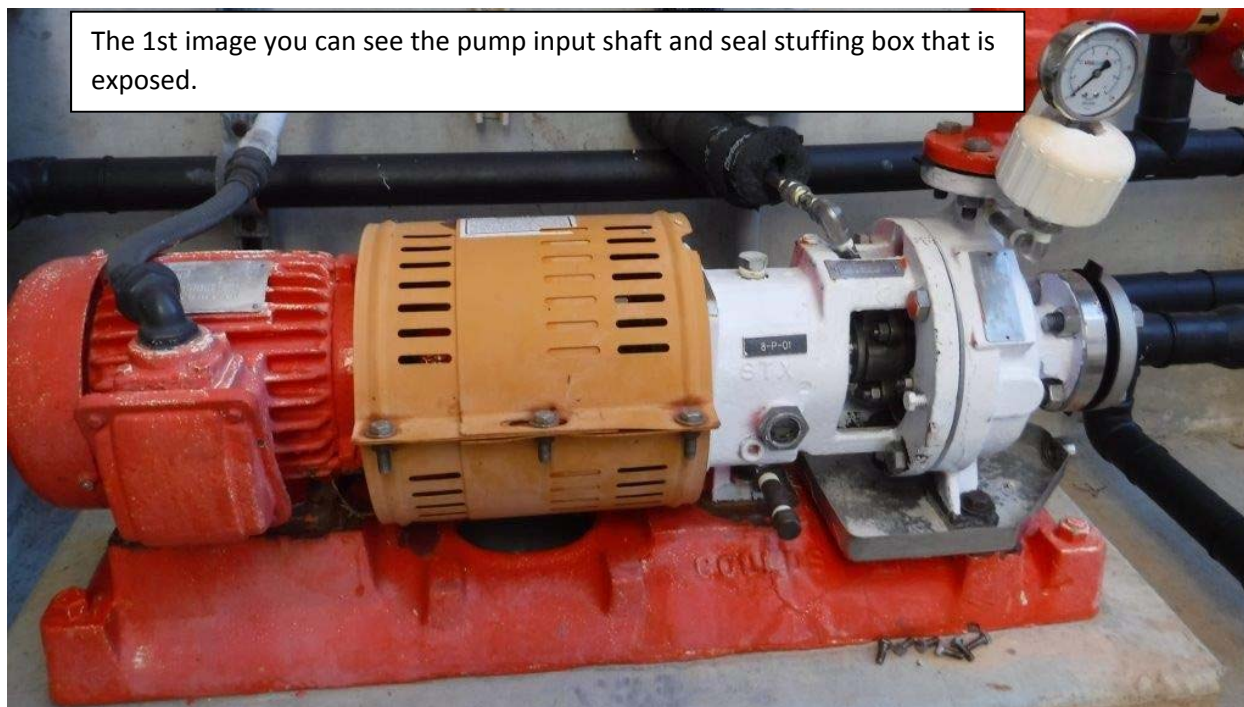
The 1st image you can see the pump input shaft and seal stuffing box that is exposed.

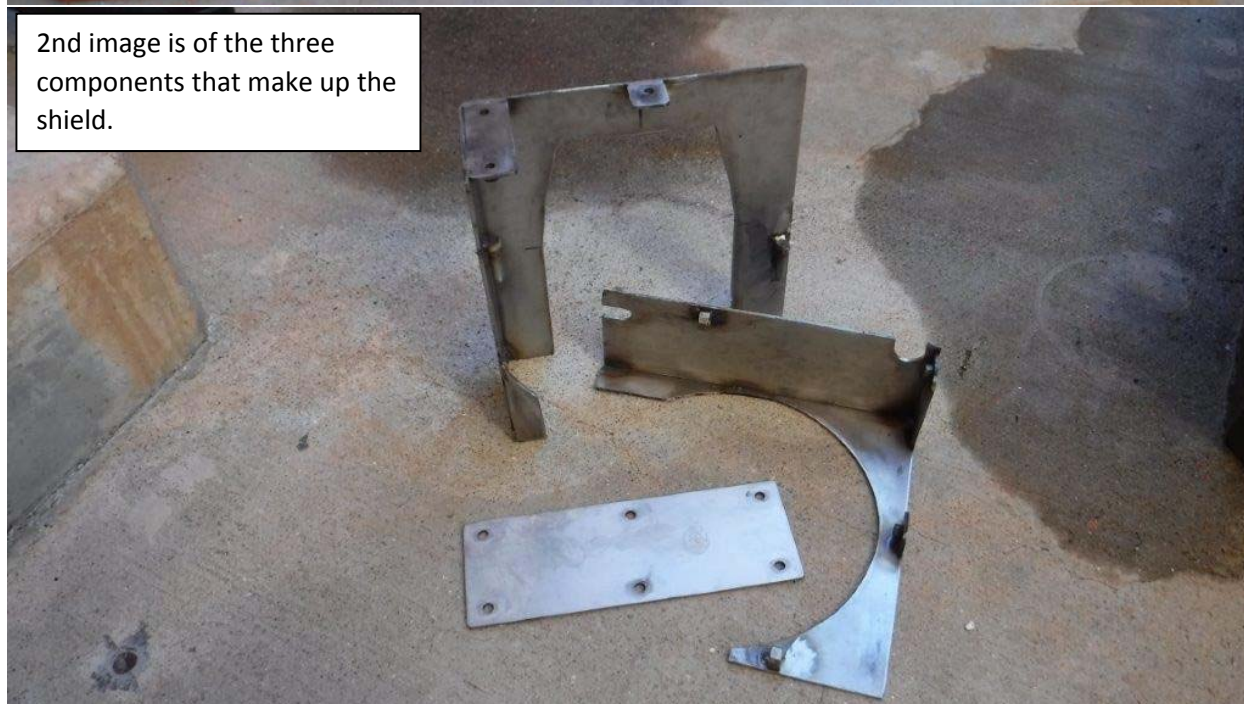
2nd image is of the three components that make up the shield.

The task criteria was to fabricate a shield that could easily be removable for inspection and repairs without having to dismantle pump or pump piping in any way. Mark's background coming from steel fabrication and welding applied his expertise and came up with a brilliant design. Mark fabricated the shield entirely from 1/8th inch 316 Stainless Steel plate and Stainless Steel cap screws.

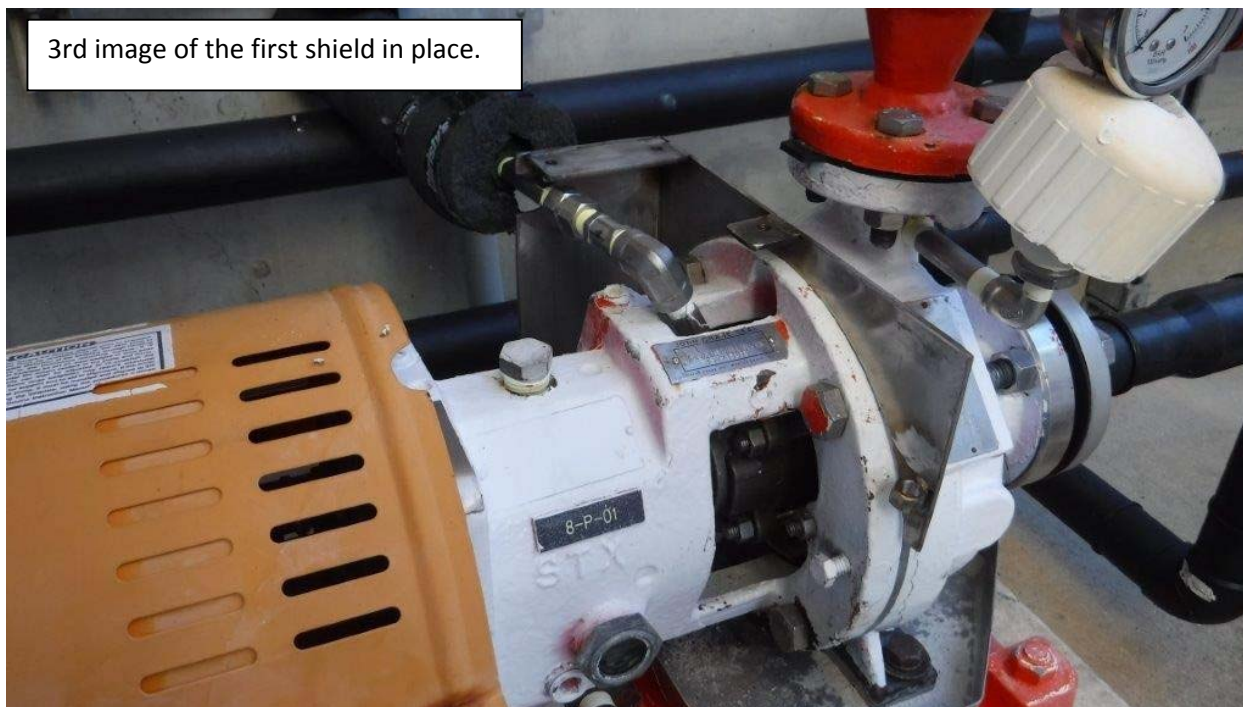
3rd image of the first shield in place.

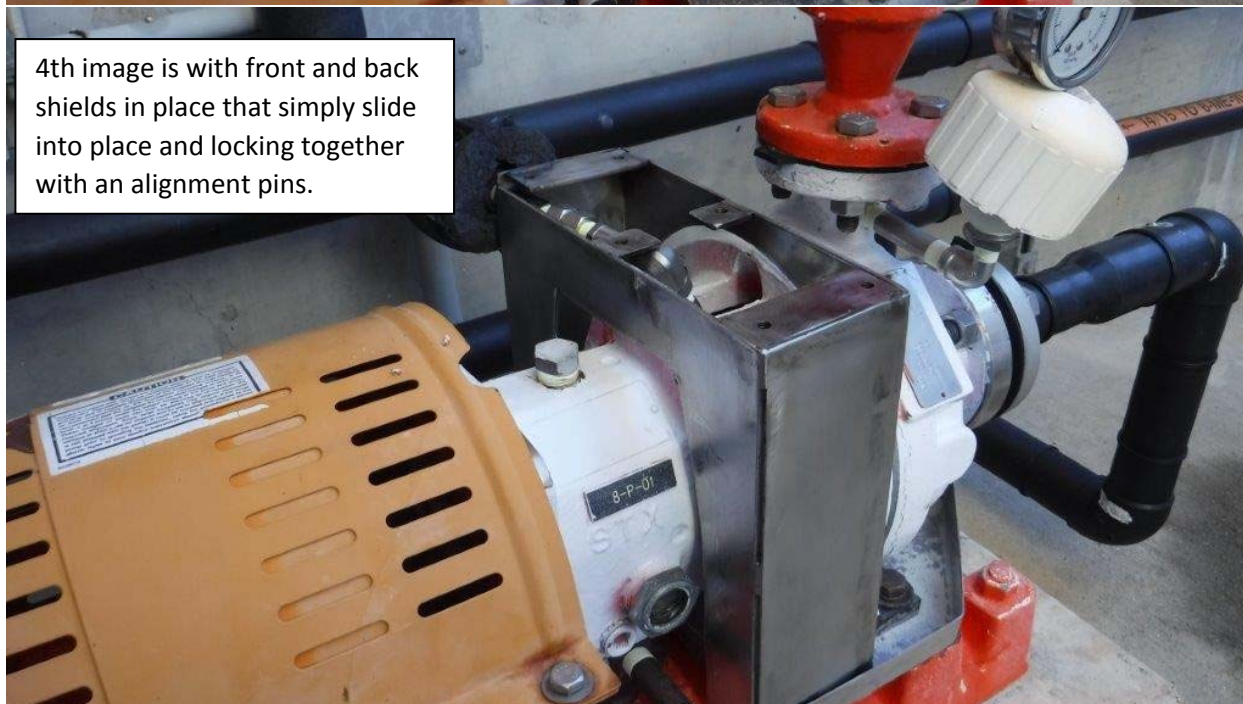
4th image is with front and back shields in place that simply slide into place and locking together with an alignment pins.

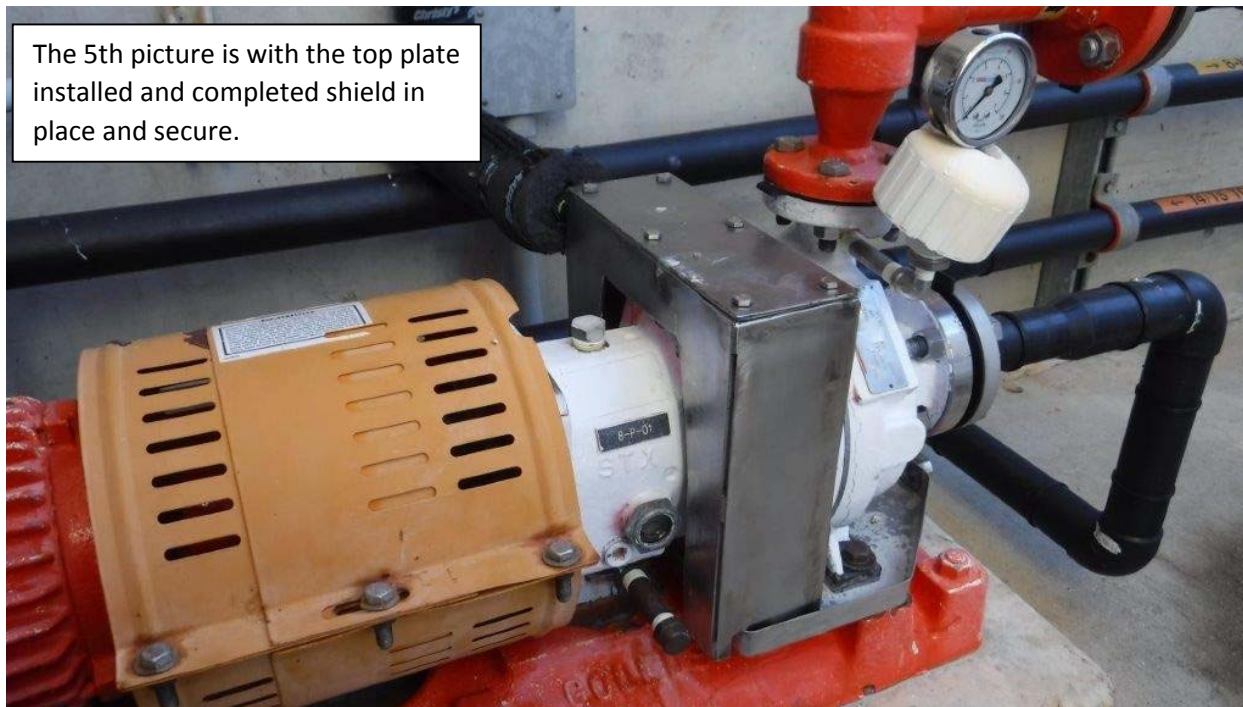
The 5th picture is with the top plate installed and completed shield in place and secure.

The shield would not prevent a release of caustic, but would direct any spray downwards into the secondary containment and stop the chemical from being released outwards, out of the secondary containment.
