Project/Initiative Title: A near miss on Yuba County Water Agency fencing project

Incident Type: A near miss on Yuba County Water Agency fencing project.

**Specific Area of Location**: New Bullards Bar Dam Road on the downstream side from just past the pedestrian gate left of the spillway to the mountain.

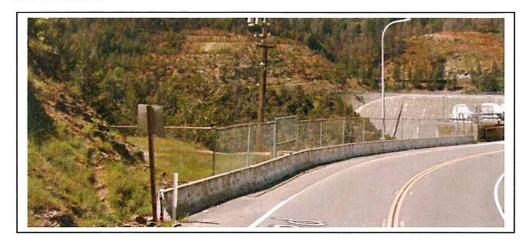
## Job Site Area

USA submitted an approval to dig near **480V** power pole with underground electricity present without on-site confirmation. The locator from PG&E said the area was approved via incorrect prints. This error had a potential for unsafe digging which could result in significant damage to personnel, public and critical infrastructure

- 0815: Although a USA ticket had been approved and granted by Pac Bell and PG&E, the contractor posed the question of safety in digging in the area as there was a power pole with a conduit evident into the ground in the job site area.

- 0820: YCWA reps stopped work for confirmation of safety in digging.
- 0830: YCWA reps contacted PG&E and they did not release any information to them due to the fact that their name was not on the ticket.

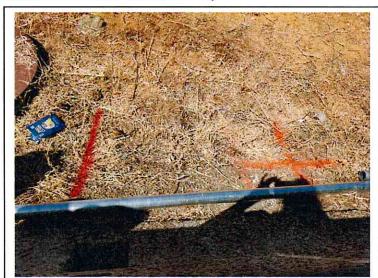
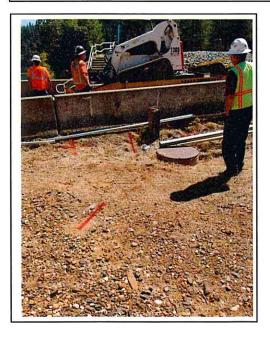
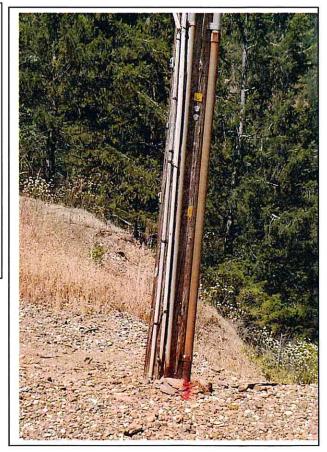
## Photos after PGE on site Survey

- 0830: The contractor called PG&E and they agreed to an onsite survey.
- 1100: PG&E was on site and found the underground power was running in between the marked post hole areas.

I wanted to share a lesson learned with you. This morning we started the fence upgrade between the spillway and the mountain, we had all our ducks in a row including a signed off ticket from USA releasing the contractors to dig, the Contractor second guessed the ticket due to the power pole with obvious underline ground conduit, we contacted ops who confirmed the underline electric. We stopped work at that point and had PGE come out to confirm and mark the underground electric. There was in fact underground cable, USA/PGE did not catch this because they did not come on site to verify, they approved the ticket from their office looking at drawings. You can see from the pictures how close the posts are to where the underground elec is (elec in red, new posts in orange). The post areas are in a safe distance from the underground electric.

- 1120: PG&E confirmed that dig area distance was safe enough to dig.
- 1130: YCWA released contractors to start work.

All is well, the digging is in safe proximity from the electric and the contractors are back in business, I just wanted to pass this experience on.
